SANITARY SEWER REPORT

Lauriston Park
Block 124, Lot 31
Borough of Rumson
Monmouth County, NJ

OSWALD ENTERPRISES – TV INSPECTION AND CHEMICAL GROUTING REPORT

DVD 1
T.V. INSPECTION AND CHEMICAL GROUTING
OF VARIOUS SANITARY SEWER LINES
OSPREY LANE, RUMSON

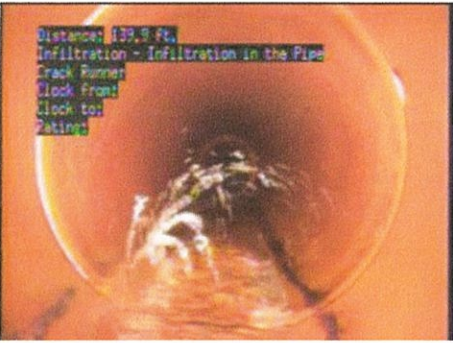
Distance	Dir.	Length	From/To	Code	Modifier/Severity	Rating	Comments
4.3 ft.	D		/	Joint	Other		
10.3 ft.	D		/	Joint	Other		
36.3 ft.	D		12 /	Lateral			
99.2 ft.	D	1.7 ft.	3 /	Crack Joint	Longitudinal		
109.4 ft.	D	2.4 ft.	6 /	Crack Joint	Longitudinal		
114.4 ft.	D	1.1 ft.	2 /	Crack Joint			
125.7 ft.	D		/	Joint - Infiltration	Weeper		
125.7 ft.	D	1.0 ft.	9 /	Crack	Longitudinal		
129.9 ft.	D	1.0 ft.	/	Crack Joint	Longitudinal		
134.9 ft.	D		/	Joint - Infiltration	Stain		
139.9 ft.	D	1.0 ft.	7 /	Crack Joint

Distance	Dir.	Length	From/To	Code	Modifier/Severity	Rating	Comments
139.9 ft.	D		/	Infiltration	Crack Runner

151.0 ft.	D		12 /	Lateral			
191.6 ft.	D		/	Crack	Circular		
343.1 ft.	D	1.0 ft.	10 /	Crack Joint	Longitudinal		
403.3 ft.	D	1.0 ft.	7 /	Crack Joint	Longitudinal		
407.0 ft.	D		/	Inspection	End

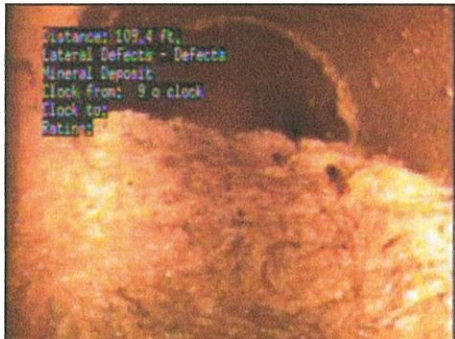
Distance	Dir. Length	From/To	Code	Modifier/Severity	Rating	Comments
5.3 ft.	D	/	Joint	Other		
11.3 ft.	D	/	Joint	Other		
67.2 ft.	D	/	Joint - Infiltration	Runner		
109.4 ft.	D	9 /	Lateral Defects	Mineral Deposit

167.4 ft.	D	/	Joint - Infiltration	Runner		
393.1 ft.	D	/	Joint	Other		
396.3 ft.	D	/	Inspection	End

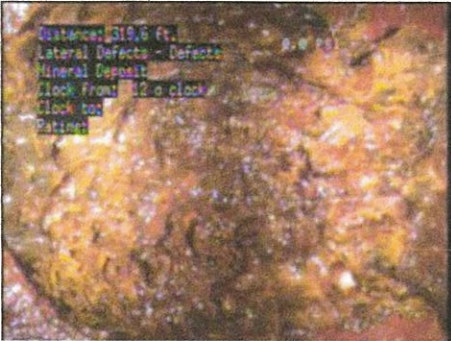
Distance	Dir.	Length	From/To	Code	Modifier/Severity	Rating	Comments
7.4 ft.	D		/	Joint	Other		
99.7 ft.	D		12 /	Lateral			
224.8 ft.	D		12 /	Lateral			
319.6 ft.	D		12 /	Lateral Defects	Mineral Deposit

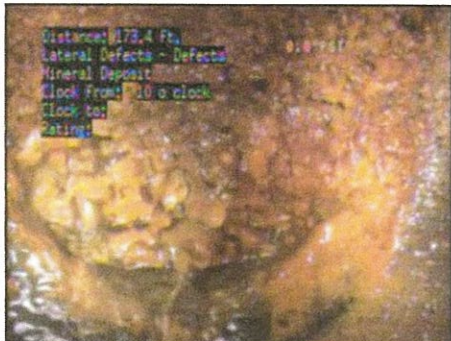
Distance	Dir.	Length	From/To	Code	Modifier/Severity	Rating	Comments
5.5 ft.	D		/	Joint	Other		
85.2 ft.	D		12 /	Lateral			
154.1 ft.	D		/	Joint - Infiltration	Runner		
173.4 ft.	D		10 /	Lateral Defects	Mineral Deposit

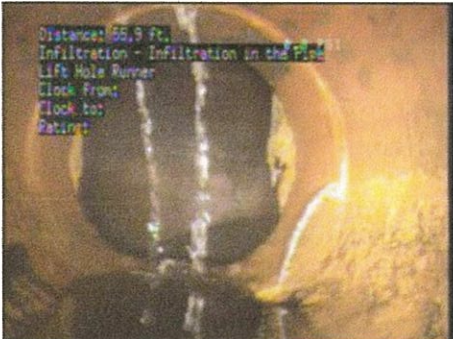
Distance	Dir.	Length	From/To	Code	Modifier/Severity	Rating	Comments
8.5 ft.	D		/	Joint	Other		
55.9 ft.	D		/	Fracture	Circular		
55.9 ft.	D		/	Infiltration	Crack Runner

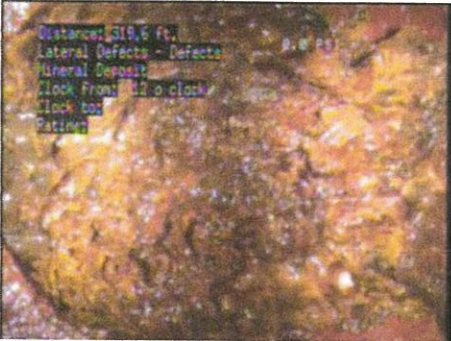
Distance	Dir.	Length	From/To	Code	Modifier/Severity	Rating	Comments
7.4 ft.	D		/	Joint	Other		
99.7 ft.	D		12 /	Lateral			
224.8 ft.	D		12 /	Lateral			
319.6 ft.	D		12 /	Lateral Defects	Mineral Deposit

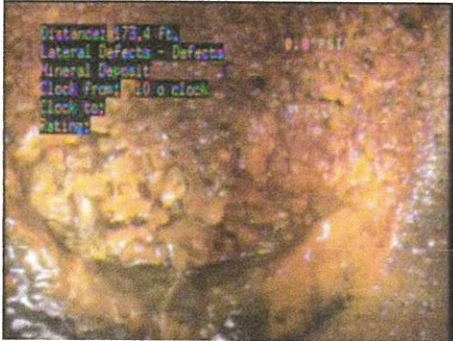
Distance	Dir.	Length	From/To	Code	Modifier/Severity	Rating	Comments
5.5 ft.	D		/	Joint	Other		
85.2 ft.	D		12 /	Lateral			
154.1 ft.	D		/	Joint - Infiltration	Runner		
173.4 ft.	D		10 /	Lateral Defects	Mineral Deposit

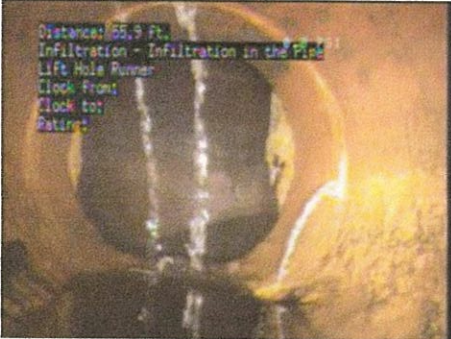
Distance	Dir.	Length	From/To	Code	Modifier/Severity	Rating	Comments
8.5 ft.	D		/	Joint	Other		
55.9 ft.	D		/	Fracture	Circular		
55.9 ft.	D		/	Infiltration	Crack Runner
